**FEBRUARY 2018**

# THIS MONTH: J.C. CONWAY'S 1969 KINGSWOOD ESTATE, 1958 LEVEL AIR SUSPENSION, 1958 MEMORABILIA

# *"Putting you first, keeps us first"* **The 1969 Chevrolet Story:** By J.C. Conway

# **1958 LEVEL AIR SUSPENSION -BY RUSSELL HEIM**

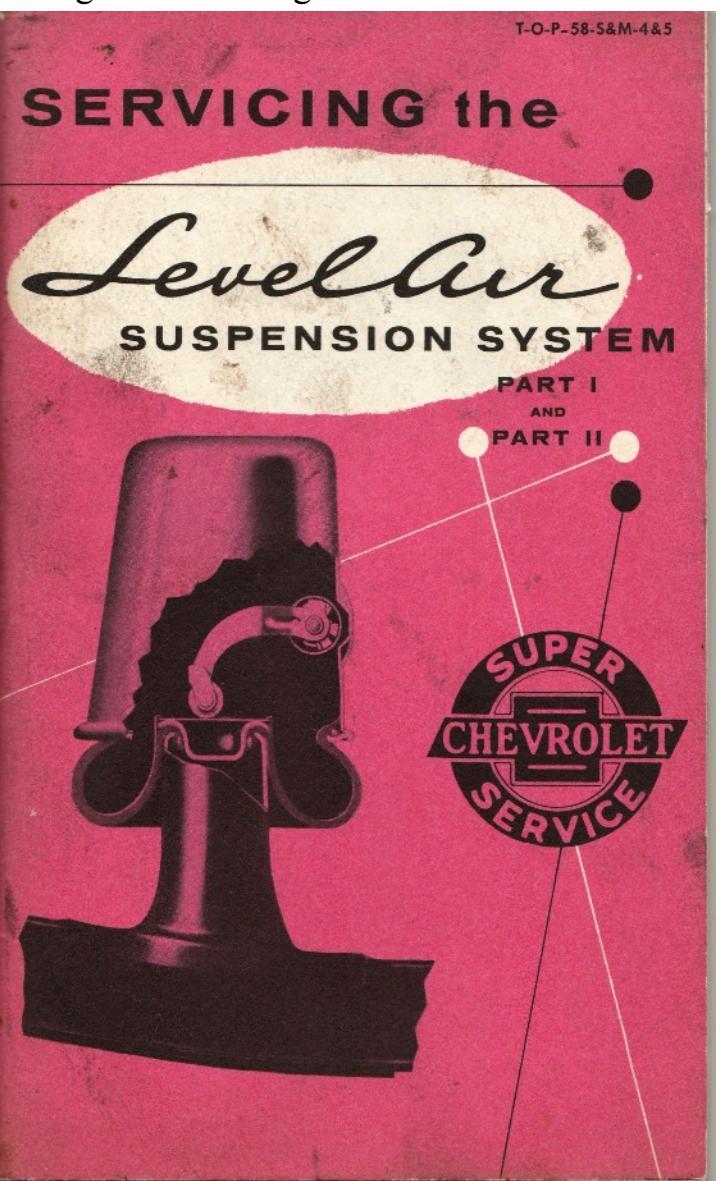
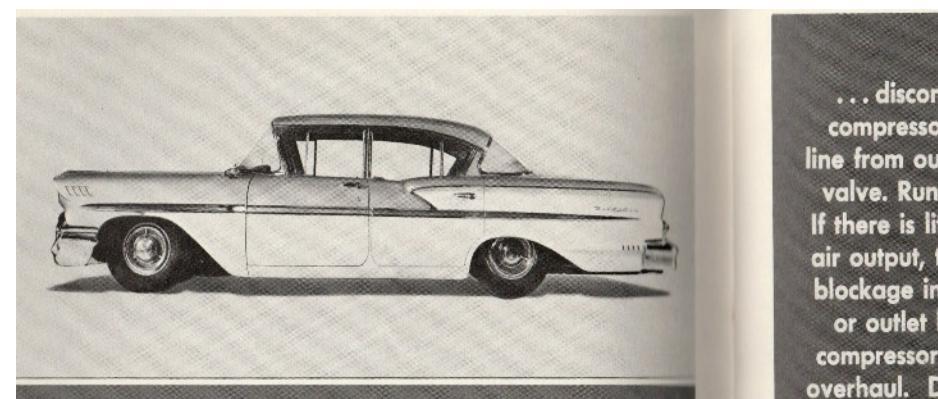
Here's how it worked: assemblies replaced the four coil springs in the both rear air springs. A balance line ran from 1958 standard suspension. Air under pressure the left rear to the right rear assembly. Each in the air springs supported the car. Each air leveling valve contained a Schrader type valve spring included a reservoir, a piston mounted on in the inlet port which was supposed to prevent the lower control arm, and a bellows.

When a wheel struck a bump, the piston was forced up into the reservoir, further compressing Air for the system was supplied by a belt-driven the air and absorbing the shock. Increased compressor and stored in an accumulator tank. compression of the air, as the piston was forced A check valve in the compressor outlet hose higher, prevented bottoming on large bumps. prevented loss of pressure through When the wheel passed over the bump and compressor when it wasn't running. dropped down again, the compressed air in the reservoir expanded to its normal pressure.

The leveling valve was mounted in the reservoir. The valve arm, which opened and closed the inlet and exhaust valves in the valve body, was rotated by the relative motion of the piston and reservoir. The inlet and exhaust valves were of Separate air lines carried exhausted air from the the flap type, with a rubber seat on each flap that leveling valves back to the junction block. This closed against an orifice in each valve insert.

High pressure air went from the accumulator to a high pressure chamber in a junction block. The junction block served as a manifold from which air lines carried air under high pressure to the leveling valves.

air went through an inlet hose to the compressor. A low pressure blow-off valve limited pressure in the low pressure side of system to 25 psi.

A relief valve limited high pressure air in the Service personnel were advised to always close system to 250 psi. Air above that pressure was the manual shut-off valve when raising a car on exhausted into the low pressure chamber where a lift. They had to always open the valve once it either returned to the compressor or was the car was lowered off the lift. When lowering pressure blow-off valve.

There was a manual shut-off valve, which when closed, prevented air in the low pressure Service men had to be sure the rear axle was chamber from returning to the compressor or centered on the hoist yoke when using a twinexhausting through the low pressure blow-off post hoist. If it wasn't centered, the yoke might valve. With the manual shut-off valve closed, have damaged the air lines at the left rear air air couldn't exhaust from the air springs. Also, spring or the gas tank, especially if air was there was a low side safety valve in the junction exhausted from the system. The front yoke block. This protected the low pressure side by needed to be correctly positioned on the lower exhausting air to the atmosphere if the manual control arms on cars with front stabilizer bars or valve was closed or the low pressure blow-off it might have damaged the stabilizer brackets. valve was inoperative. This valve exhausted at 165 psi. Air required to replace lost air during operation entered the system through an air cleaner in an alcohol bottle.

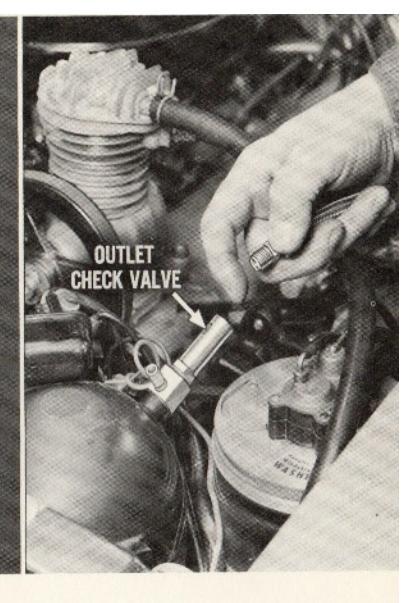
5. NO BUILD-UP OF AIR PRESSURE. This is probably caused by a faulty compressor, a complete blockage in compressor outlet line, the high pressure relief valve stuck open, or a large leak in system. Check as follows — ... disconnect compressor outlet line from outlet check valve. Run engine. If there is little or no air output, there is a blockage in air inlet or outlet lines or compressor requires overhaul. Disconnect inlet and outlet lines from compressor to check for blockage.

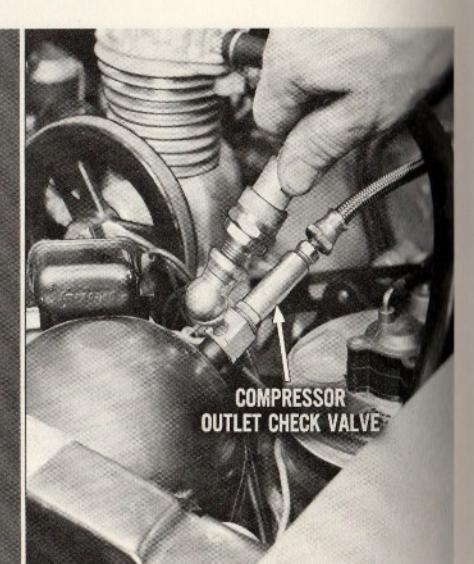
Add air at high pressure Schrader type valve. If car rises, the difficulty is in the check valve or compressor. To determine which is at fault . . .

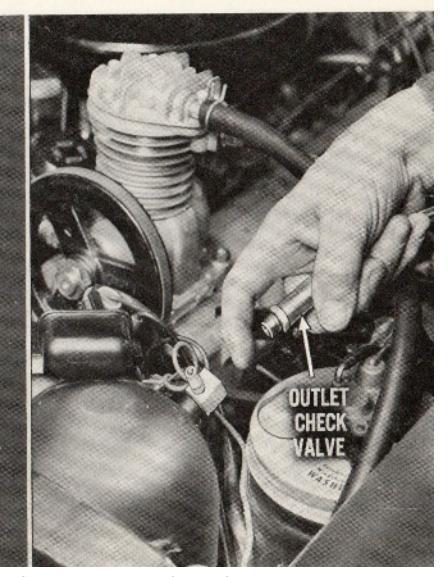
If there is a strong surge of air, outlet check valve is probably stuck closed. Test by installing check valve on end of outlet line. If no air comes through, valve is stuck and must be replaced.

A few illustrations and procedures from the Level Air Suspension service manual. Photos courtesy of the John Mahoney collection.
